Tool Life And Surface Finish Evaluations In Dry Milling Of AISI D2 Tool Steel

Abstract Good control and planning of cutting parameters and optimization of cutting conditions requires prediction of tool wear and surface finish. This paper presents a study of tool life and surface finish while machining AISI D2 tool steel. Milling tests were performed under dry cutting condition in order to avoid thermal shock on the brittle carbide tool. Various cutting speed and feed rates were tested while the axial and radial depth of cuts were set to be constant for all trials. Repetitions for each set of cutting condition were made three times and shortest tool life was taken. The results showed that the flank wear starts with an initial stage and it is followed by gradual stage and finally abrupt stage of wear. Mechanical wear or abrasion is typically dominant during the initial cutting. Majority of the tool wear modes were due to flank wear and excessive chipping on the tool edge. Maximum tool life is obtained at a cutting speed of 50 m/min and feed rate of 0.02 mm/rev. The effect of increasing feed rate on tool life is most significant and occurs at the lowest speed of 50 m/min. The life of

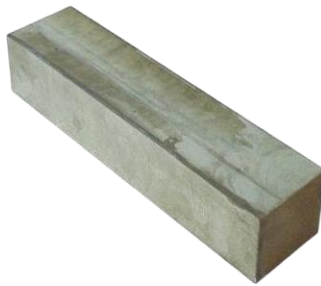
The cutting performance is tested on AISI D2 tool steel bars (Figure 3) that have been hardened to 62 HRC. The dimension of the workpiece material provided is 305 x 70 x 53 mm³ to comply with the provisions of ISO 8688-2. The composition and properties of the workpiece materials can be seen in Table 3 and 4, respectively.

**Figure 3:** Workpiece**Table 3:** Chemical composition of AISI D2 tool steel

The workpiece material is cleaned by removing the surface layer at a certain thickness to ensure that there is no hard skin layer compared to the bulk material formed as a result of oxidation and during the forming process.
